SECOND NOTICE - 3M™ Versaflo™ TR-801N Powered Air Purifying Respirator Motor/Blower Product Advisory

**Immediate Action Required**

## Product: 3M™ Versaflo™ TR-801N Powered Air Purifying Respirator Motor/Blower

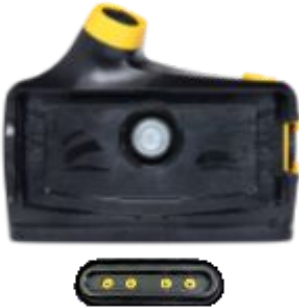
3M Personal Safety Division has identified that certain 3M™ Versaflo™ TR-800 Powered Air Purifying Respirator (PAPR) motors/blowers manufactured between September 2024 and April 2025 may contain a component that could cause them to not conform to their Intrinsic Safety (IS) rating. A list of affected serial numbers is included in Appendix A of this letter.

The affected TR-801N PAPR motor/blower assemblies may include electrical battery contact pin assemblies that do not meet the intended classification requirements for IS in hazardous locations, as indicated on the product label.

For affected products, the assembly of the electrical battery contact pin(s) may not correspond with the design used during the IS certification process. In such cases, if the plunger/pin does not maintain contact with the pin housing when depressed and the unit is running, the current from the battery can cause the spring inside the pin assembly to heat up. If this occurs, the temperature of dust-protected pin assembly components could potentially exceed the stated T4/135oC temperature rating. This increase in temperature could reach the autoignition temperature of certain gases and vapors that may have diffused into the battery connector assembly and be present at a concentration within their flammable or explosive limits.

**Step 1:** Locate the adhesive label on the bottom of the TR-801N PAPR motor/blower housing with the product serial number (circled in red below).

**Step 2:** Determine if the product serial number is one of the products affected. See Appendix A below.

**Step 3:** To coordinate the return of your affected product(s) for replacement visit the following website to view the details and complete the electronic intake form at:
